Denial-of-Service Vulnerability in MELSEC iQ-R Series C Controller Module

Release date: October 7, 2021
 Last update date: July 7, 2022
 Mitsubishi Electric Corporation

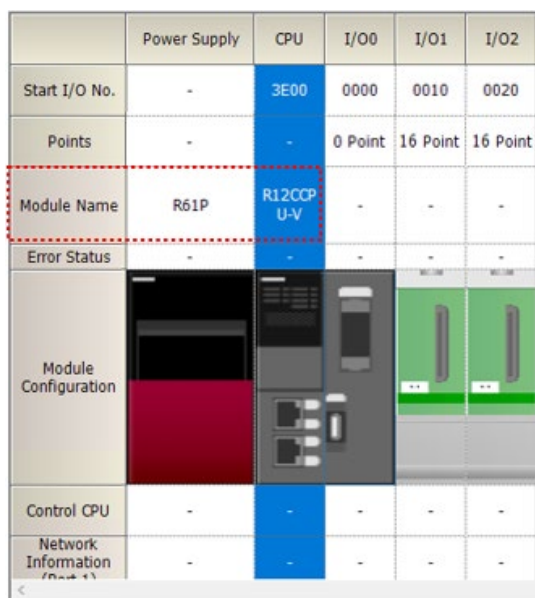
The Module Name and Firmware Version of the module can be checked on the window of system monitor in CW Configurator.

Product Information List						
	Network Information (Port 2)	IP Address (Port1 IPv4)	IP Address (Port2 IPv4)	Module Synchronous Status	Firmware Version	Production information
Basic-Power Supply	-	-	-	-	-	-
Basic-CPU	-	192.168.3.3	0.0.0.0	-	14	-
Basic-I/O 1	-	-	-	-	-	-
Basic-I/O 2	-	-	-	-	-	-
Basic-I/O 3	-	-	-	-	-	-
Basic-I/O 4	-	-	-	-	-	-
