Mitsubishi Electric Corporation **Industrial** Robot

MELFA Technical News

BFP-A6079-0192E

Subject: Change of J1 axis lubrication position.
Affected item: RH-6FH series

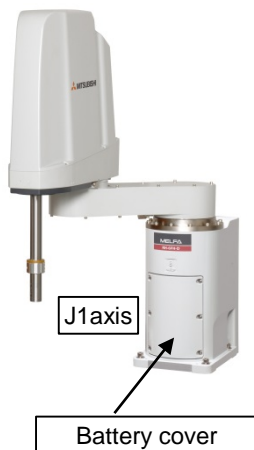
Before	After
Lubrication position

(1) The refueling position and the lubrication procedure of the J1 axis reducer will be changed.

Lubrication method	<ol style="list-style-type: none"> (1) Remove the battery cover. (2) Inject grease from grease nipple for lubrication with grease gun. 	<ol style="list-style-type: none"> (1) Remove the bolt at the lubrication point and install the supplied grease nipple. (2) Inject grease from grease nipple for lubrication with grease gun. (3) Remove the attached grease nipple and attach the original bolt.

(2) Along with this change, the contents of "Section 5.3.6 Lubrication" in "5. Maintenance and inspection" of "Instruction manual BFP-A 8864, BFP-A 3314" will be changed.

Serial number on the rating plate is "*** 707001" or later. (** indicates the alphabet)
